EAST MARSHALL COMMUNITY SCHOOL DISTRICT

FACILITY CONDITION ASSESSMENT
June 2, 2020

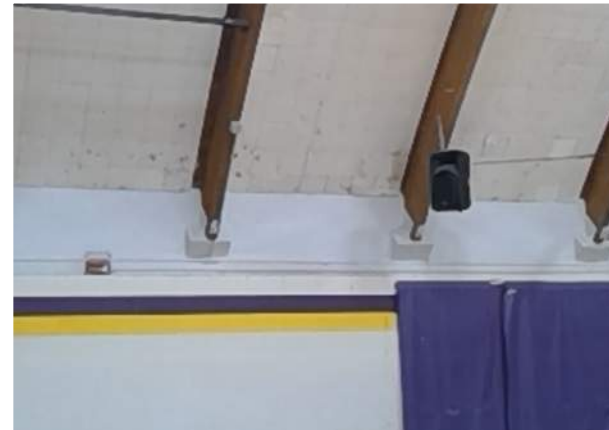
Existing conditions

Ceiling finishes in select classrooms have reached end of useful life. Ceiling tiles in gym are susceptible to damage during activities.

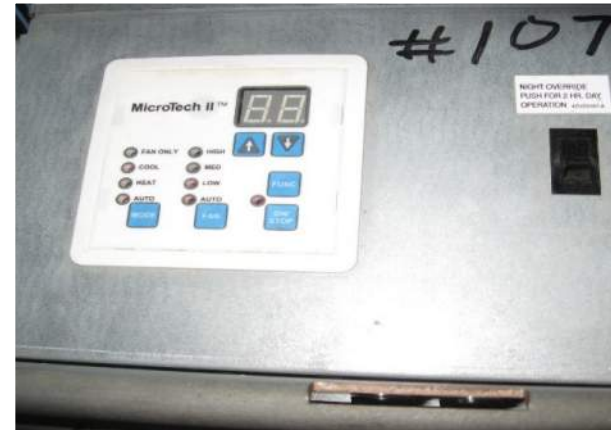
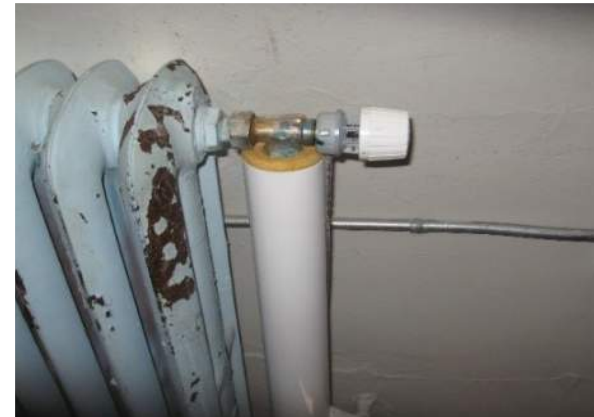
Existing conditions

Steam heating units have manual controls. Trane through-wall units LAN boards are failing. No exhaust hoods above ranges in FCS. Boiler is nearing end of expected life.

Provide new electronic control in steam heating units. Replace controls program in the Trane through-wall units. Provide exhaust hoods over ranges. Replace boiler in next 5 years.

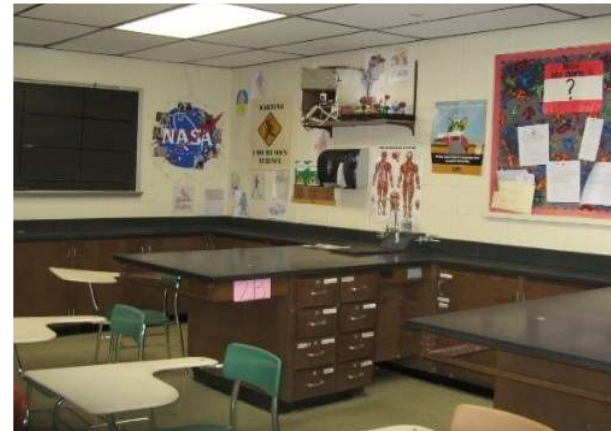
Existing conditions

No backflow preventer on the domestic water. No emergency gas shutoff, emergency shower or eyewash stations in two science classrooms. There is a pipe that comes up through the middle of a storage room floor presenting a tripping hazard.

Provide backflow preventer and ground jumper wire around the water meter. Provide new emergency gas shut off valve, new emergency shower and eyewash stations in both science classrooms. Relocate pipe to remove trip hazard.

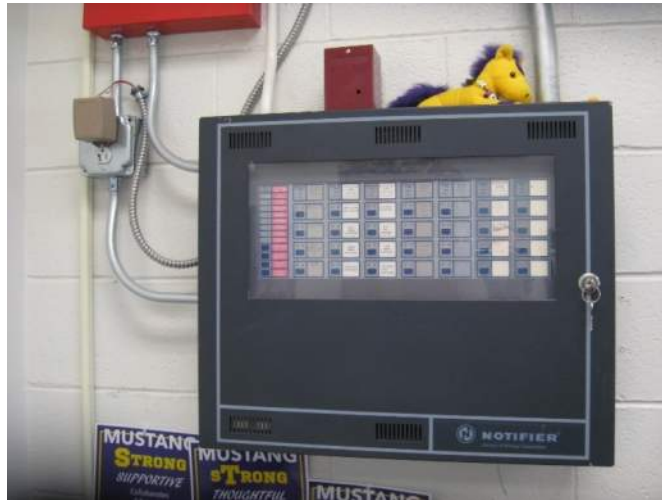
Fire Alarm Panel

The fire alarm system in the building is an older zone-type system that has outlived its life cycle. We recommend that this be replaced with a new addressable system with voice notification to meet code. Depending on the Authority Having Jurisdiction (AHJ) in the area, a fully sprinkled building may be required if upgrading the fire alarm system.

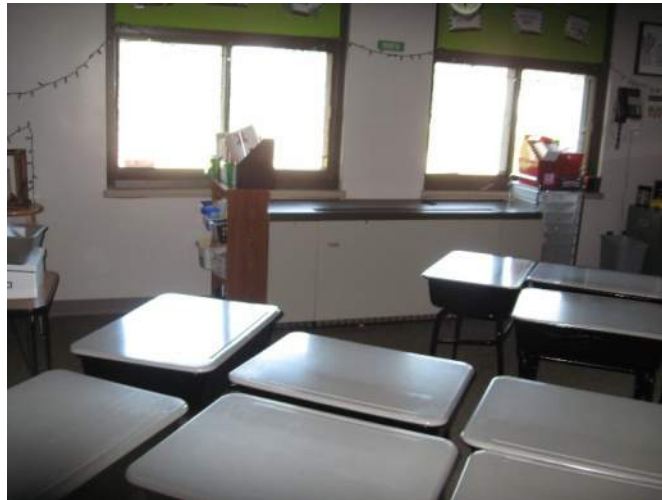
Trane Through-the-Wall Unit

The control boards on the Trane through-the-wall units are failing. The boards cost \$2,000 to replace and do not give the desired control. We recommend the school contact a controls contractor to address this. We discussed with Woodman Controls in Des Moines who believes they can help with this issue.

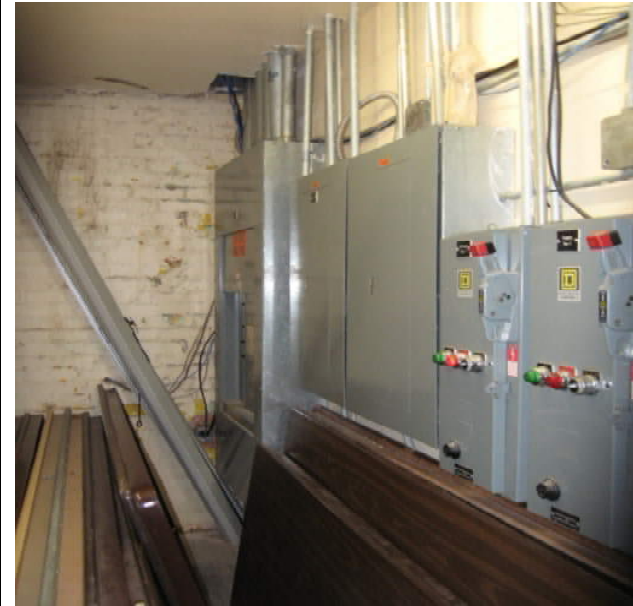
Electrical Panels

Tables are blocking access to the electrical panels and are creating a code violation. Code requires 36" clearance in front of panels for accessibility. No cost on this as it is a housekeeping issue.

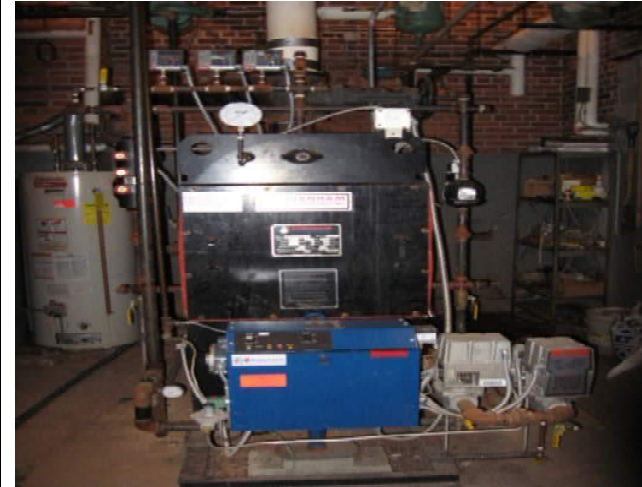
Boiler

The boilers have outlived their life cycle and should be put on a schedule to be replaced.

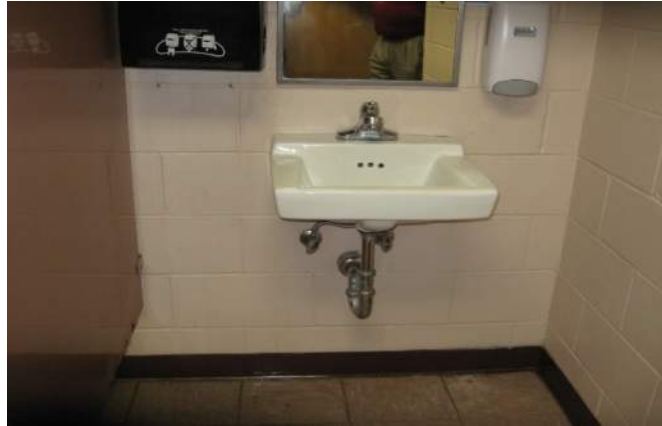
Sink Without Lavatory Guard

The restrooms in the older part of the facility do not meet current ADA standards. There are no lavatory guards on the pipes under the sinks.

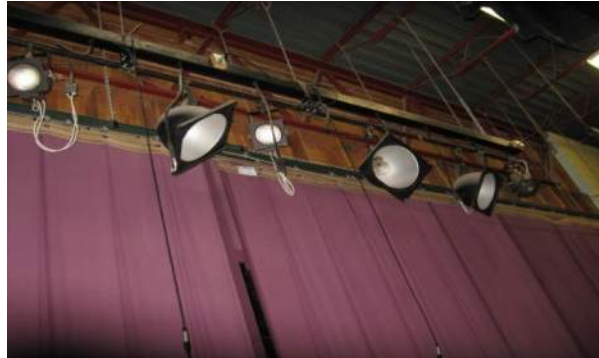
Stage Lighting

The stage lighting has outlived its life cycle and should be scheduled for replacement.

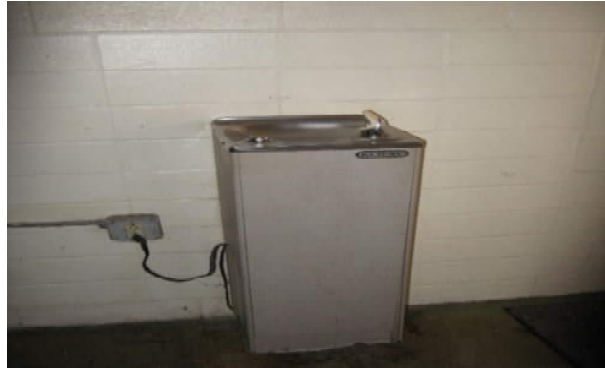
Water Fountain

There are three water fountains that we saw the do not meet current ADA standards. We recommend that these be scheduled for replacement.

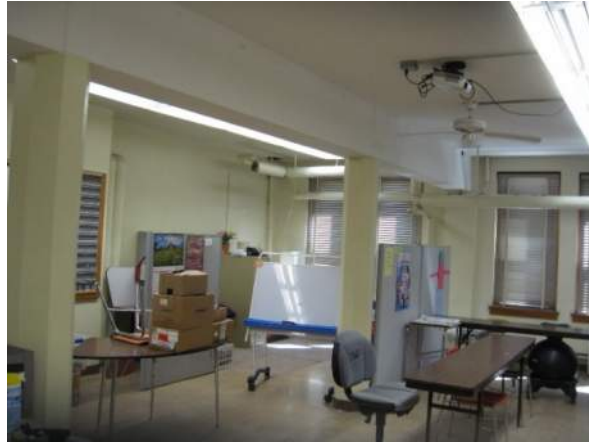
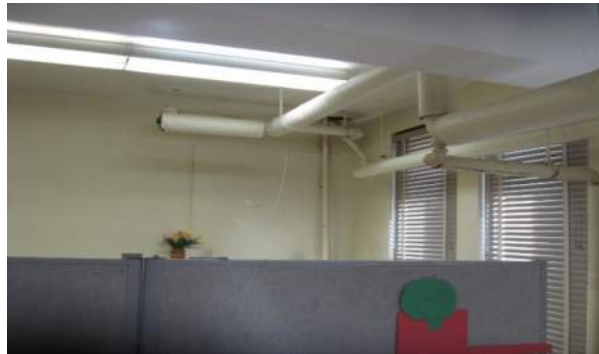
Uninsulated Pipes

Heat control in this room is very uneven due to the uninsulated pipes, consistently giving off heat. Recommend insulating pipes.

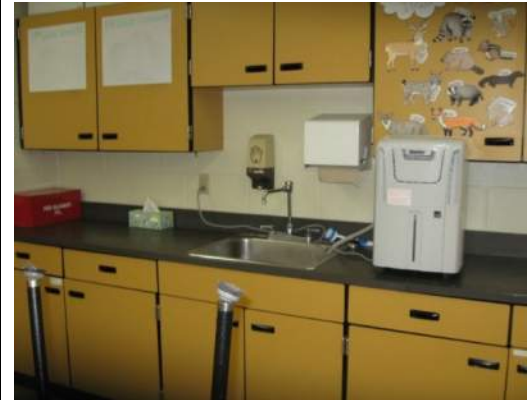
Dehumidifier

The building has humidity issues causing damage to the facility. New HVAC System

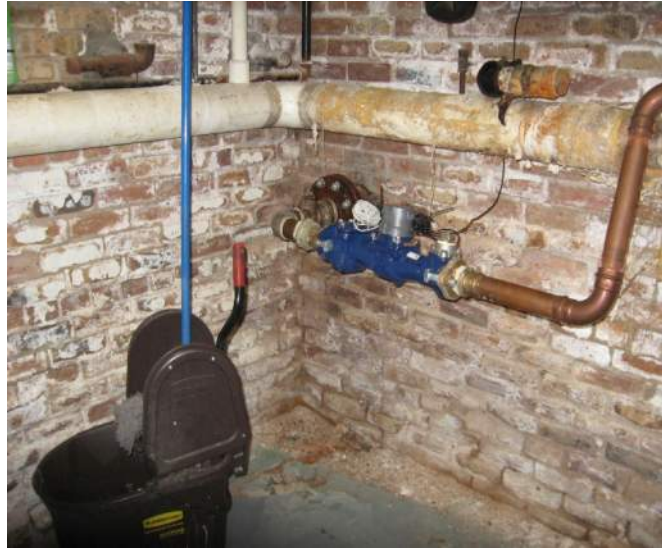
Missing Jumper on Water Meter

There is no ground jumper on the water meter. This is an electrical code violation. There should also be a backflow preventer.

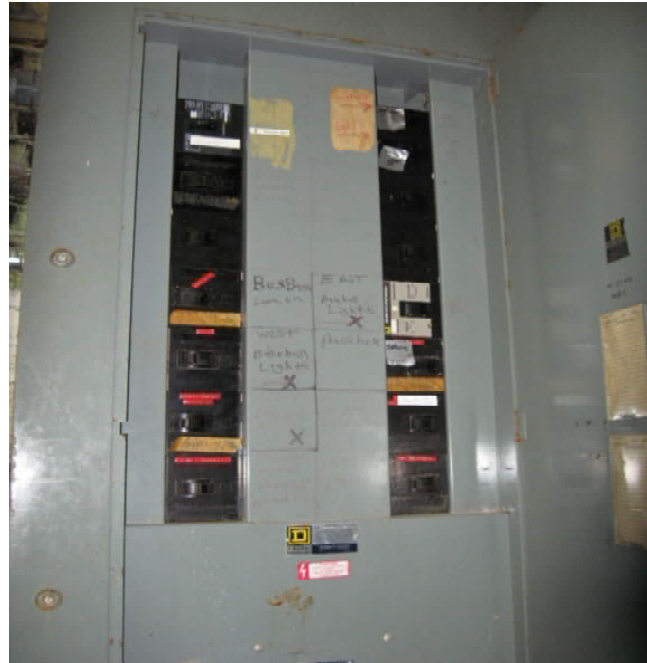
Electrical Distribution Panel

The electrical distribution panel has outlived its life cycle and should be scheduled for replacement. While parts are currently still available, it should be replaced in the future. Replace all the old panels.

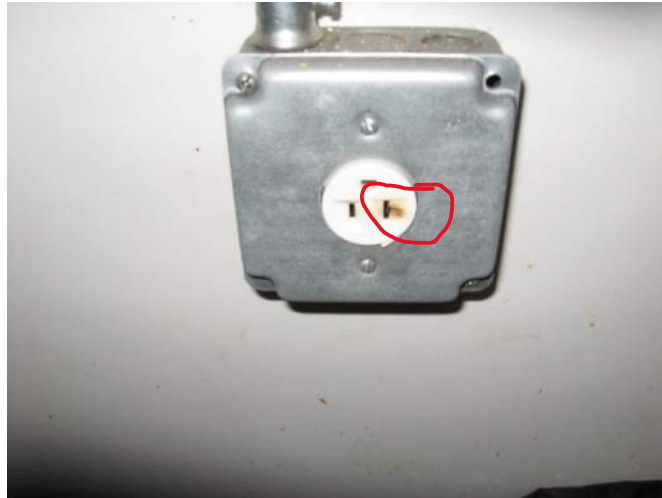
Receptacle in kitchen shows signs of high heat. It probably has a loose connection causing it to build heat. It should be replaced before it causes problems.

Receptacle Shows Signs of High Heat

Robb (with CSD) stated he would have this changed.

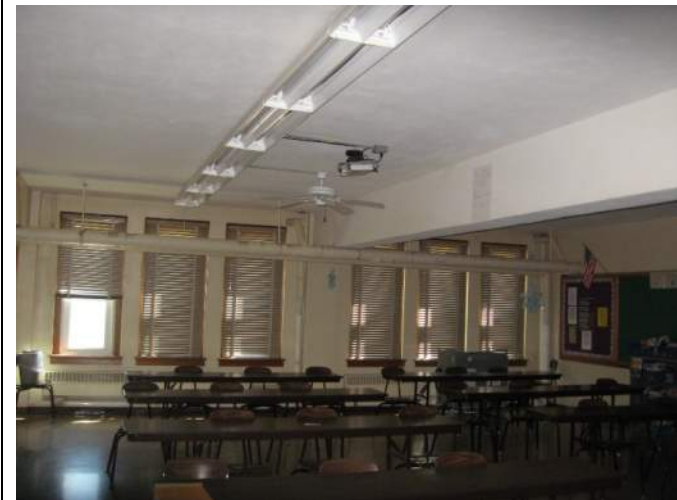
The fire alarm system appears to have been replaced at one time. However, it does not meet code. The building has no sprinkler system and should have a full smoke detection system in place. Many of the classrooms do not have smoke detection. Depending on the AHJ when updating the fire alarm, they may require that a sprinkler system be installed.

Room Showing no Smoke Detection

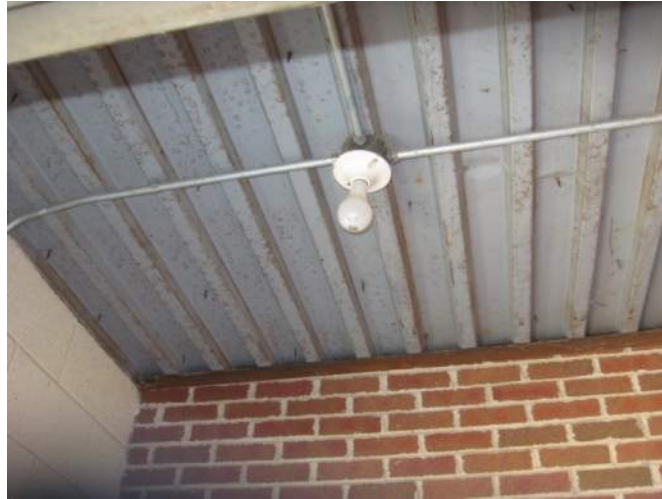
Light Outside Entrance

Light at outside entrance should have a wire guard or be an enclosed fixture instead of an exposed light bulb.

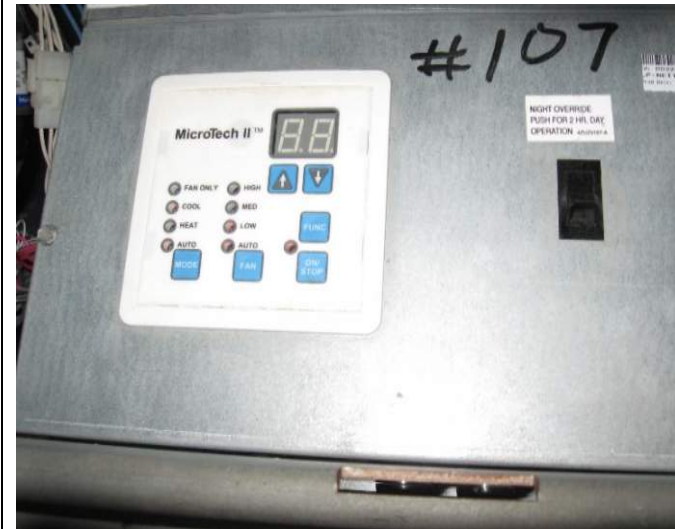
Through-the-wall Unit

The control boards on the Trane through-the-wall units are failing. The boards cost \$2,000 to replace and do not give the desired control. We recommend the school contact a controls contractor to address this. We discussed with Woodman Controls in Des Moines who believes they can help with this issue. Circuit boards would need to be changed out and then new controls.

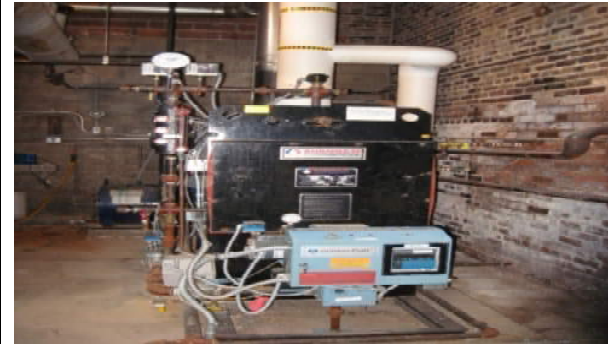
Existing Boiler

The boiler was installed in 2008 and is nearing the end of its life cycle. It should be scheduled to be replaced in the next 5 to 10 years.

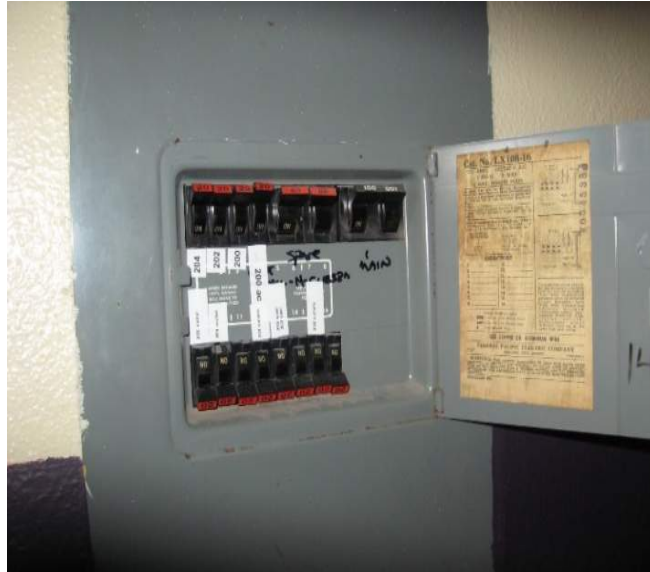
Federal Pacific Electrical Panel

This is an old Federal Pacific electrical panel. Parts have not been made for this since the early 1970's and parts are getting hard to find. This panel should be scheduled for replacement soon.

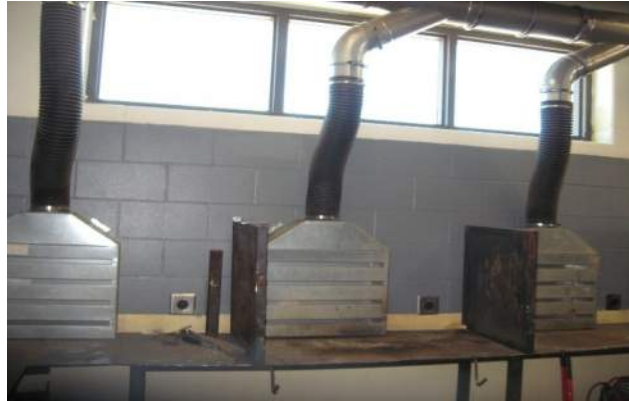
There does not appear to be a balancing damper in any of the ducts going to the welding stations. This can cause one station to work well and others will not.

Needs Balancing Damper at Each Station
