EAST MARSHALL COMMUNITY SCHOOL DISTRICT

FACILITY CONDITION ASSESSMENT
June 2, 2020

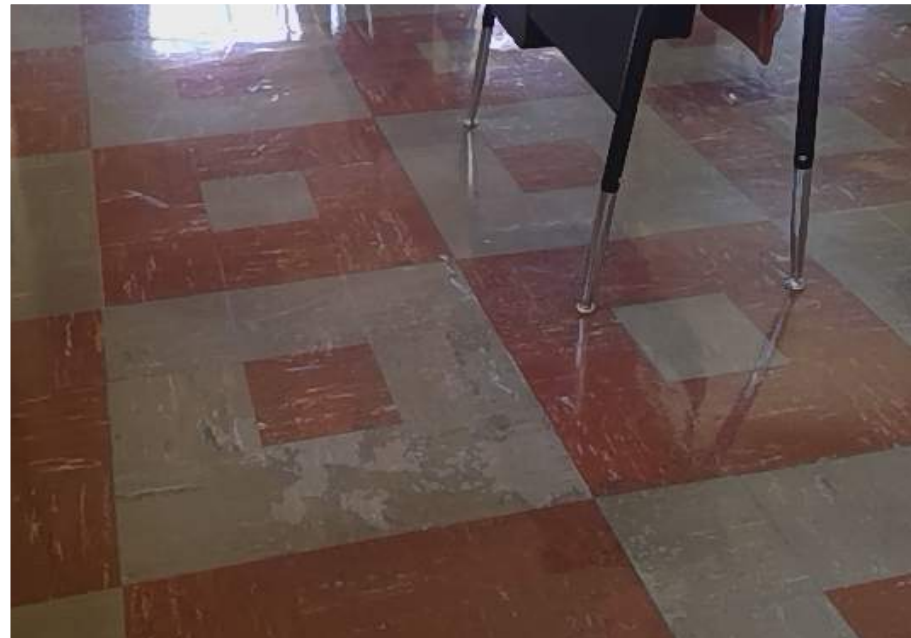
Existing asbestos containing floor tile

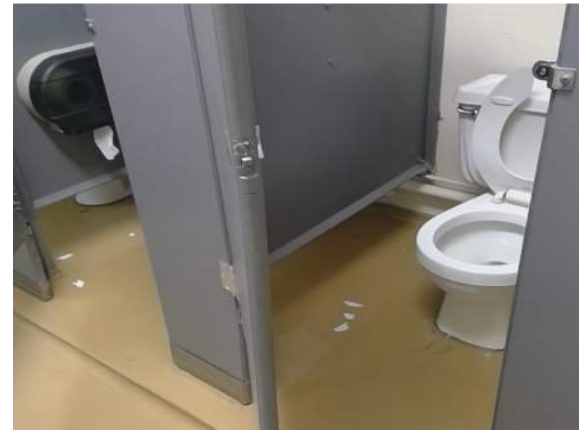
Existing conditions

Renovate restrooms to meet ADA requirements and update finishes. Provide dual height drinking fountains, replace knob type hardware with lever action. Modify 30 seats for ADA compliant seating at bleachers.

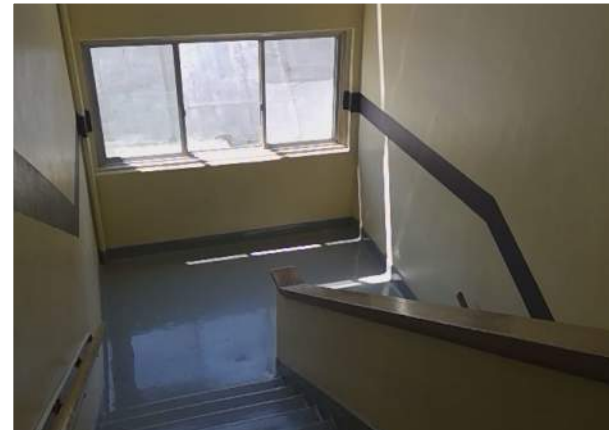
Existing conditions

Modify the existing handrails and guardrails to meet code (lower cost) or replace with new (higher cost). Replace wire glazing and glass block at fire rated walls with new fire rated glazing. Provide new hollow metal door frames and re-install existing doors. Provide emergency lighting to be code compliant.

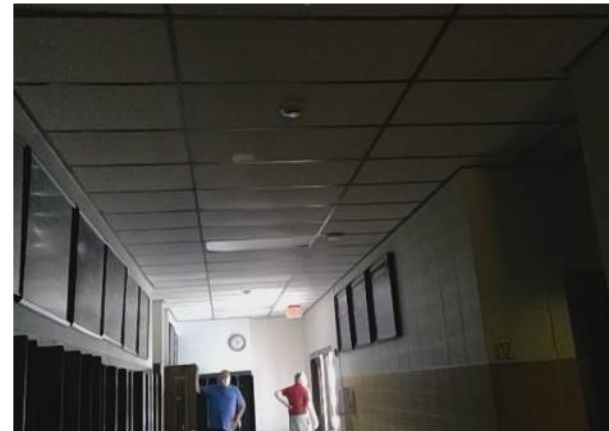
Existing conditions

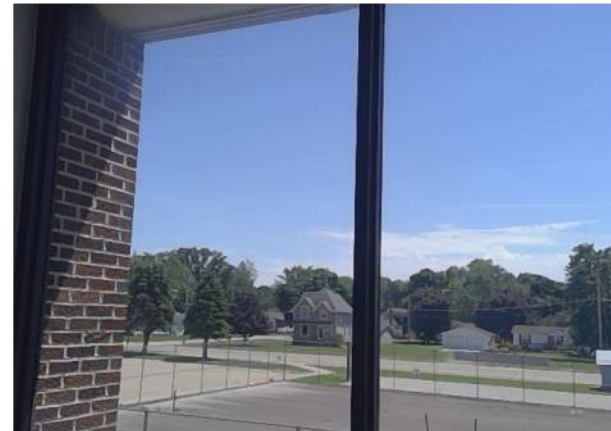
Existing conditions

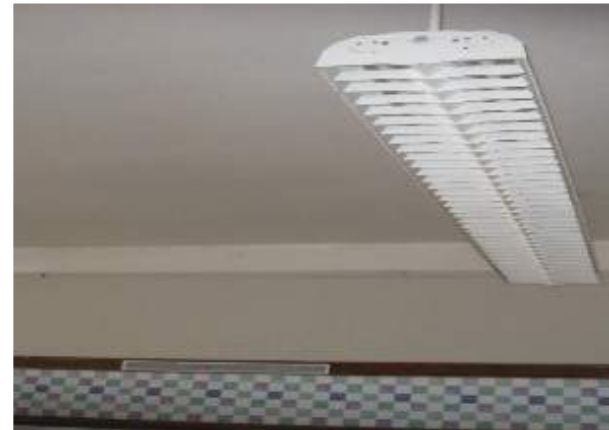
Existing conditions

Replace existing light fixtures with new energy efficient LED fixtures/lamps. Update lighting controls using occupancy sensors and daylight harvesting.

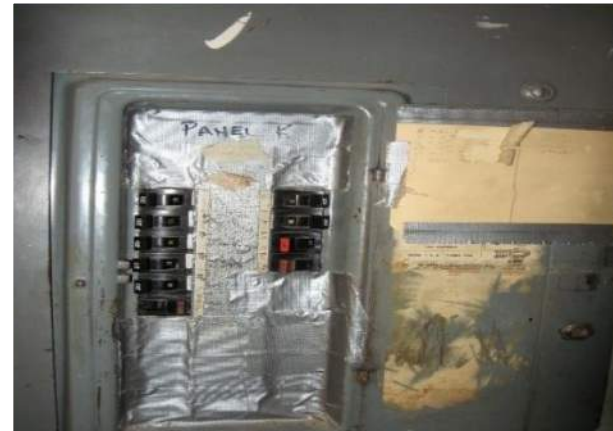
Existing conditions

Replace existing electrical panels with new electrical panels.

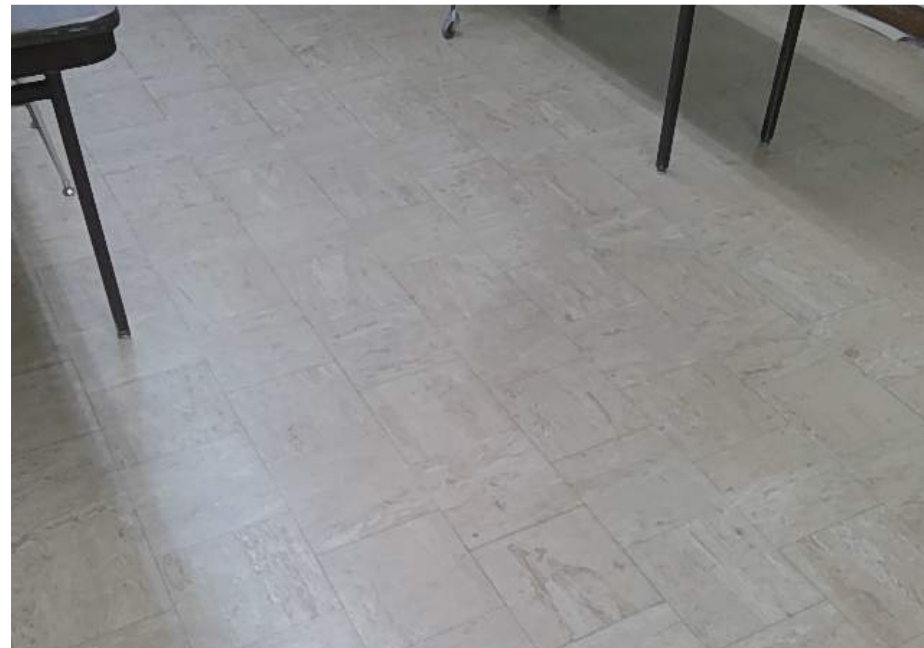
Existing asbestos containing floor tile

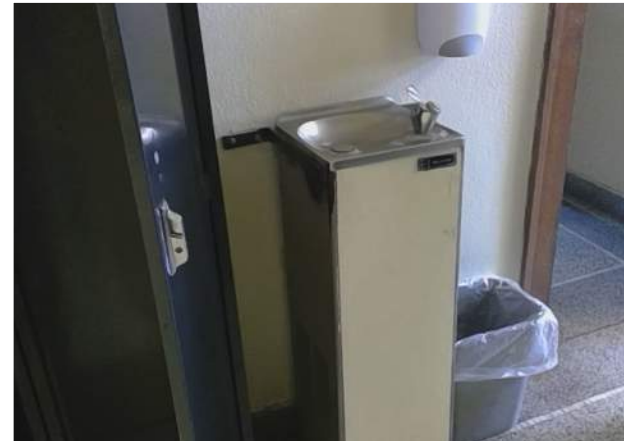
Existing conditions

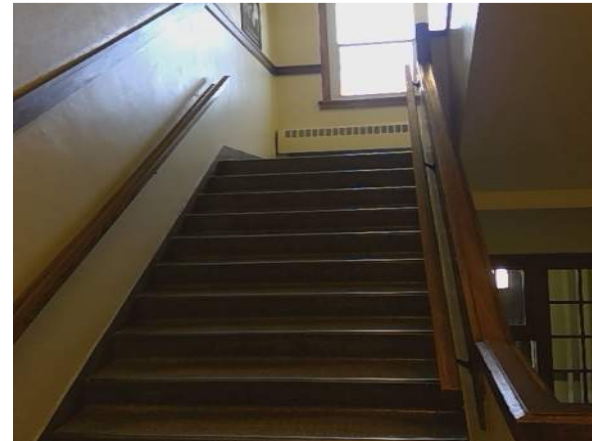
Existing conditions

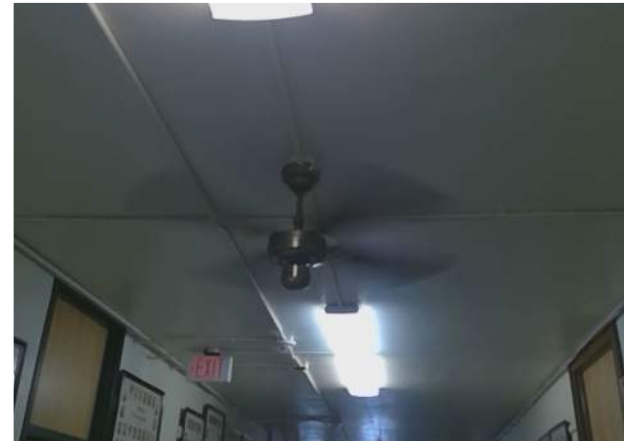
Existing conditions

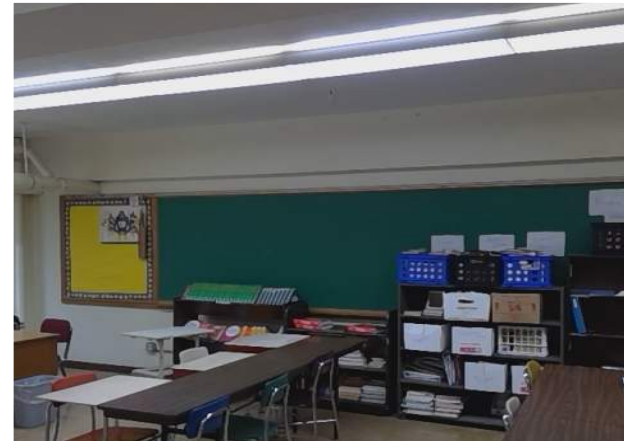
Existing conditions

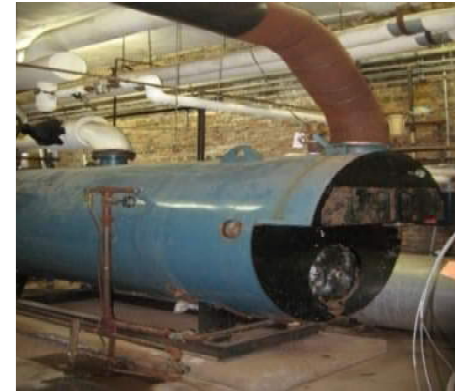
2.02 New Heating, Ventilation & Air Conditioning Systems

Existing conditions

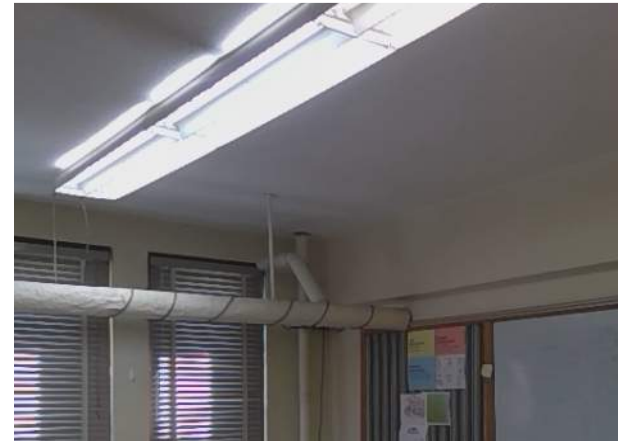
Existing conditions

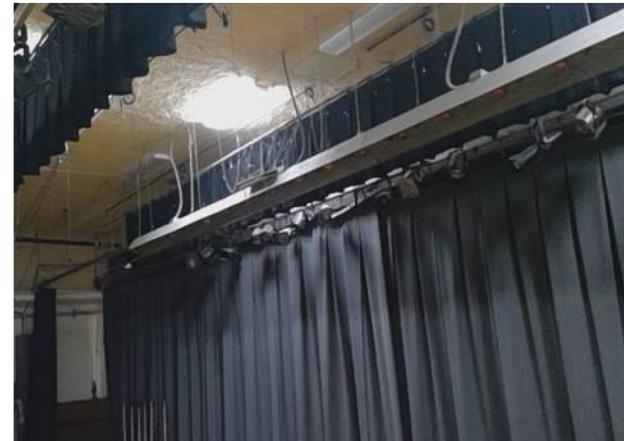
Existing conditions

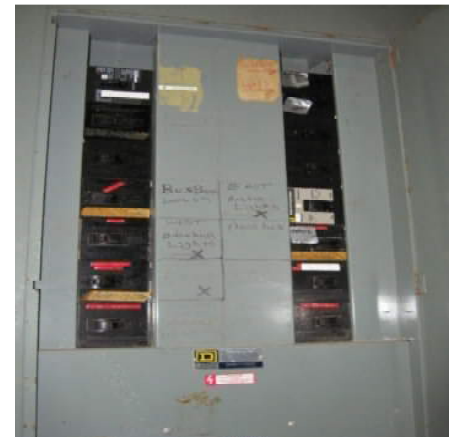
Existing conditions

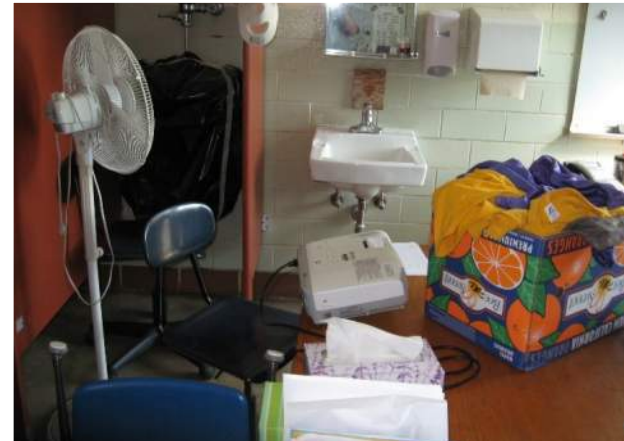
Existing conditions

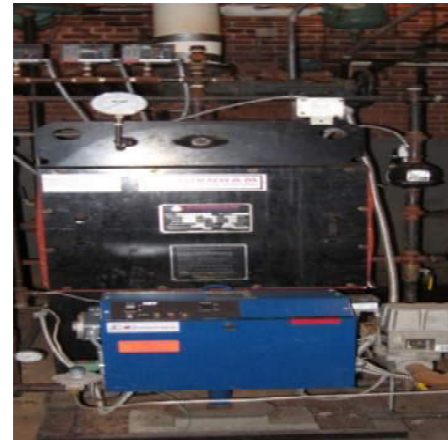
Existing conditions

Steam heating system has manual control. Trane through-wall units LAN boards are failing. Boiler has outlived expected life cycle. Only half of the facility is air conditioned.

Provide new automated, electronic control system. Replace controls program in the Trane through-wall units. Provide new boiler. Provide new air conditioning system in portion of building with none.

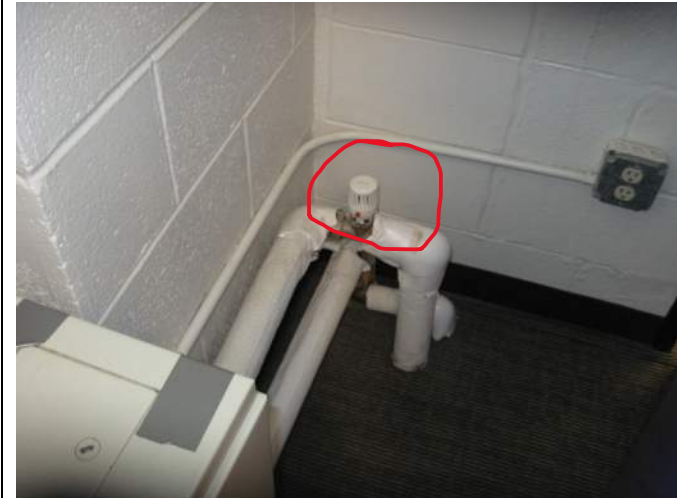
Boilers at North Mechanical Room

The steam heat has manual control. The units would be better controlled with an automated, electronic control system. This would also allow the building maintenance engineer to adjust the temperatures from a computer. It will not help with uneven heat.

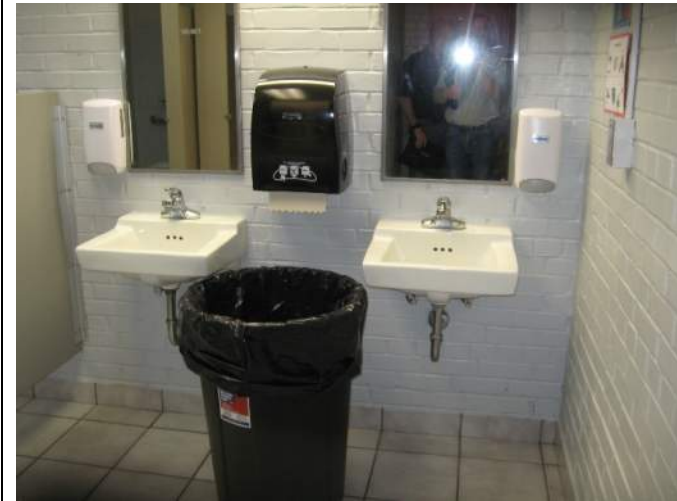
Sinks not to ADA Standards

Restrooms also do not meet current ADA standards for handicapped access. There are no lavatory guards on the pipes under the sinks.

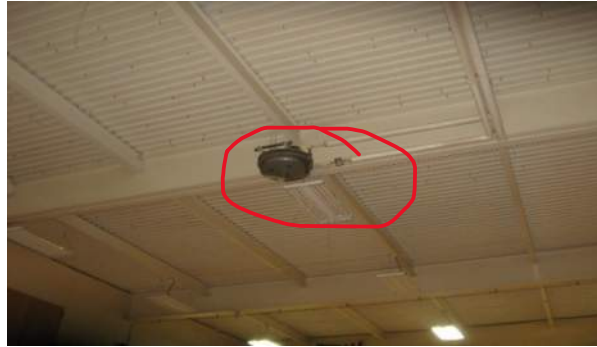
Gym Steam Unit Heater

Steam unit heater in gym has outlived its life cycle and should be replaced with a more energy efficient heater.

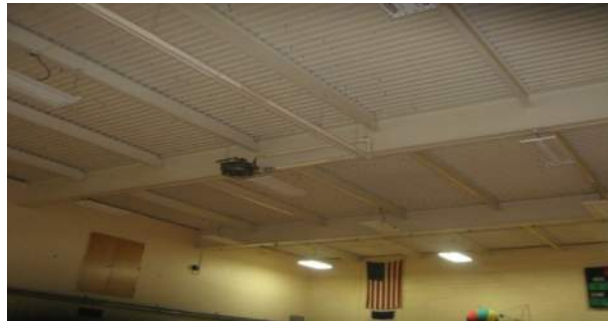
Fluorescent Lighting

There is fluorescent lighting in the gym and most of the school. Better and more efficient LED lighting should be considered to replace the old fluorescent lighting; this would include the rest of the school. Use LED replacement lamps.

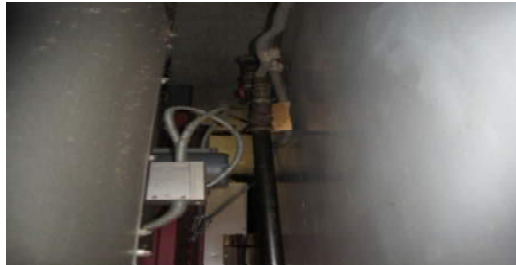
Electrical Equipment Under Kitchen Exhaust Hood

The electrical equipment under the exhaust hood is not shunt tripped off on Ansul activation. This is required per current code, but does not need to be done unless a kitchen upgrade is done.

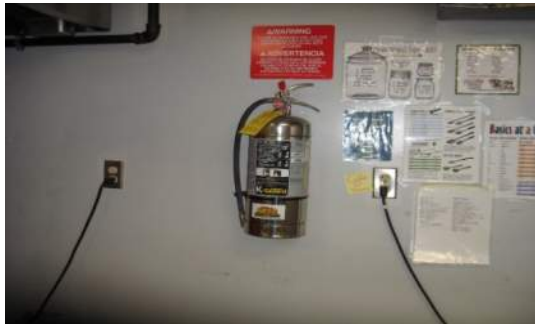
Non-GFCI Receptacles in Kitchen

Per current code, all receptacles in the kitchen shall be GFCI protected. If a kitchen upgrade is done, these receptacles would need to be changed to GFCI.

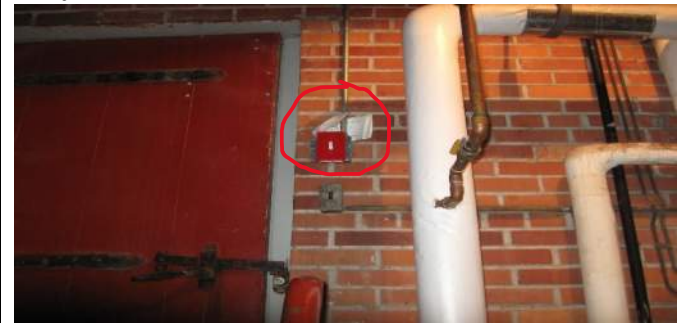
Boiler Emergency Shut-off Switch

The emergency boiler shut down is a typical light switch and should be a mushroom-head type, so that it does not get shut off by accident.

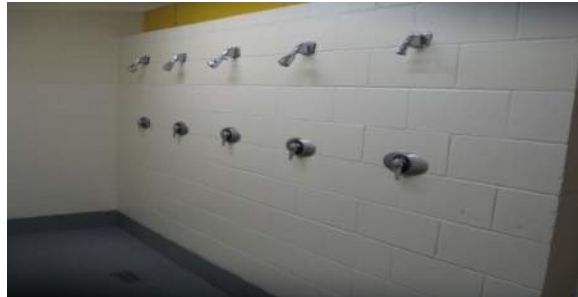
Locker Room Showers

The locker room showers are not ADA compliant. Gang type showers do not meet ADA Standards; individual shower stalls are now required. This would not need to be updated until a renovation is done. Price is for replacing all fixtures.

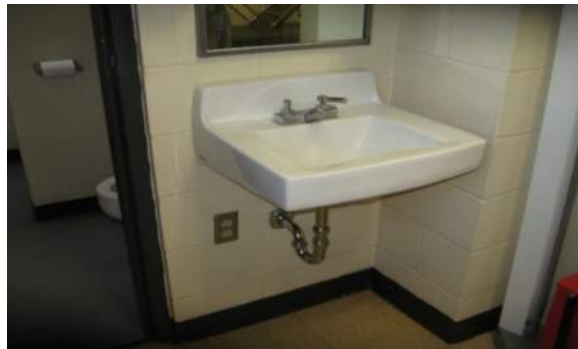
Locker Room Lavatory

The lavatories do not meet current ADA standards, as they do not have pipe guards under the sink.

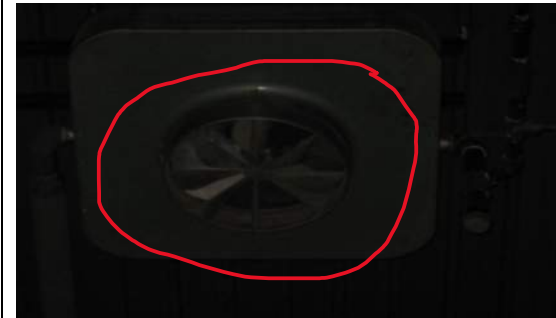
Steam Unit Heater in Gym

The gym steam unit heaters have outlived their life cycle and should be scheduled for replacement with a more energy efficient model.

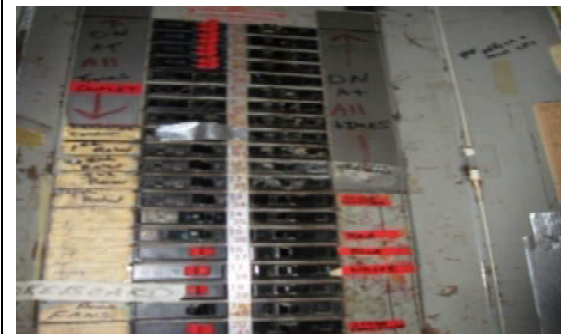
Breaker Panel

The electrical panel on the stage has outlived its life cycle. These panels have not been made since the early 1970's and should be replaced as parts are hard to find.

Replace distribution panels with new. Provide new electrical panel at stage. Modify electrical components under the kitchen hood to be shunt tripped off on Ansul system activation.

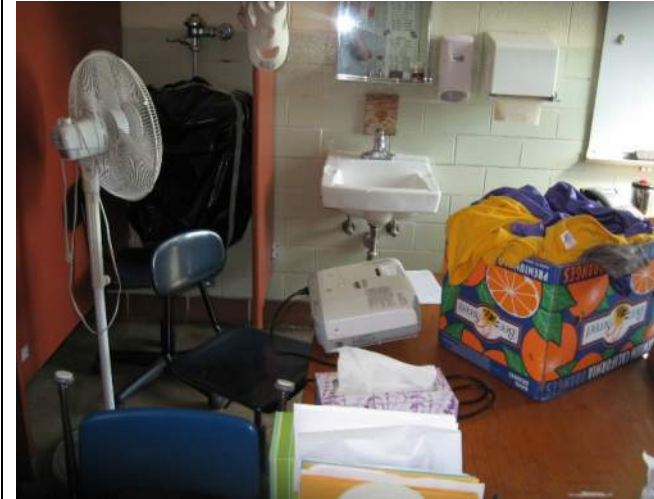
Coaches Room

Coaches restroom does not have a functioning urinal and the water closet does not meet current ADA Standards.

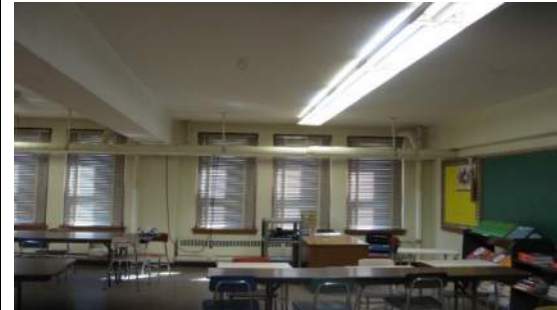
Room Steam Heat

Room heat is very uneven. This condition is typical with steam heat in large rooms with the heaters on one side of the room. Electronic control would allow better control of the system, but will not help with uneven heat.

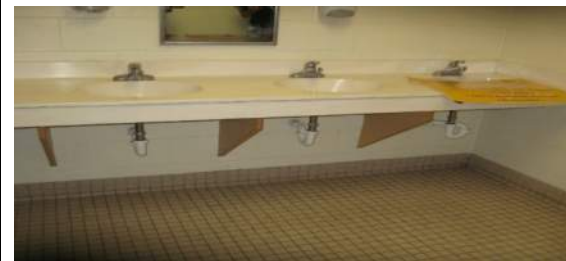
Restroom Lavatory

The restroom sinks do not meet ADA standards. Pipes under the sinks do not have lavatory guards on them and the faucets are not bath-handle type. These would need to be replaced if there is an upgrade to the restrooms.

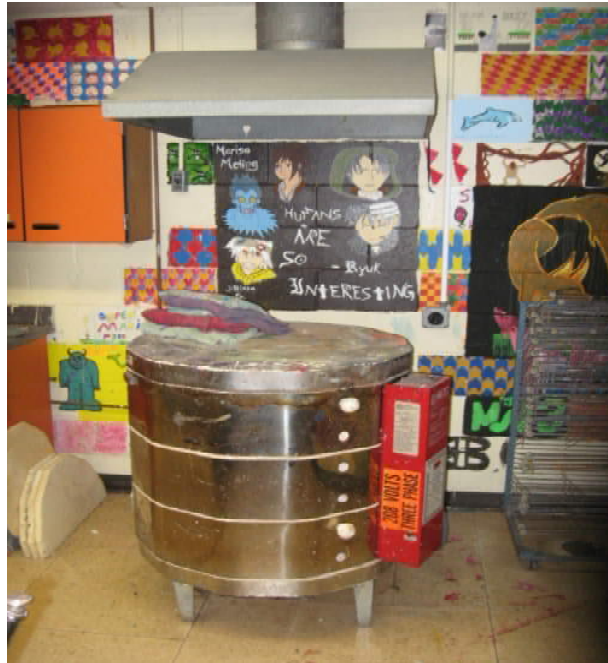
Kiln in Classroom

Per the ASCIP (Alliance of Schools for Cooperative Insurance Programs) a kiln should not be operated in a classroom. Kilns put off a lot of heat, and even with an exhaust hood, could give off harmful fumes when opened. It is not good practice to put kilns in the classroom. The kiln and associated exhaust and electrical should be moved to another room. See Estes to enclose or make a room for this.

Provide a new building automation system to control temperature, a new boiler and air conditioning system. Provide new gym unit heaters with more efficient models. Insulate piping to provide improved energy efficiency. Relocate kiln and provide exhaust.

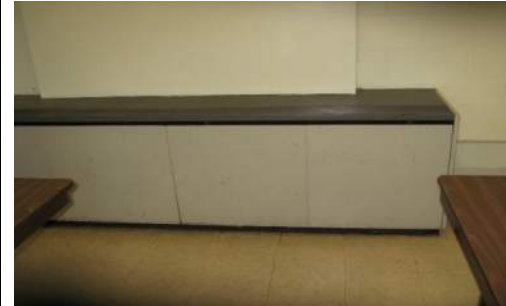
Through-the-wall Unit Ventilator

We were informed that the through-the-wall heaters are noisy and give uneven heat in the room.

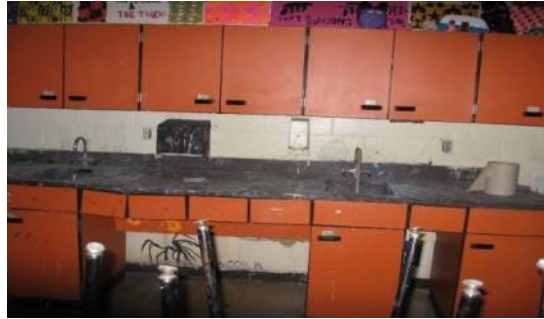
Receptacles Without Cover Plates

There are several cover plates missing in the art room. This creates a safety hazard and a code violation.

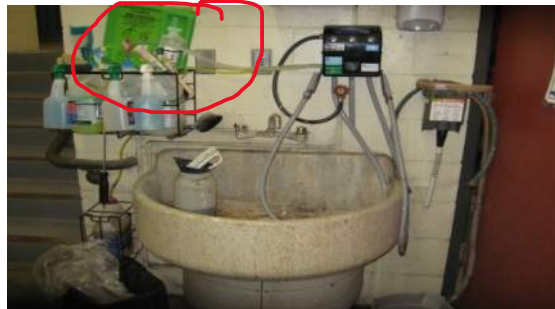
Eyewash Blocked

The eyewash by the sink is blocked by a chemical rack. Should consider having a combination eyewash/shower.

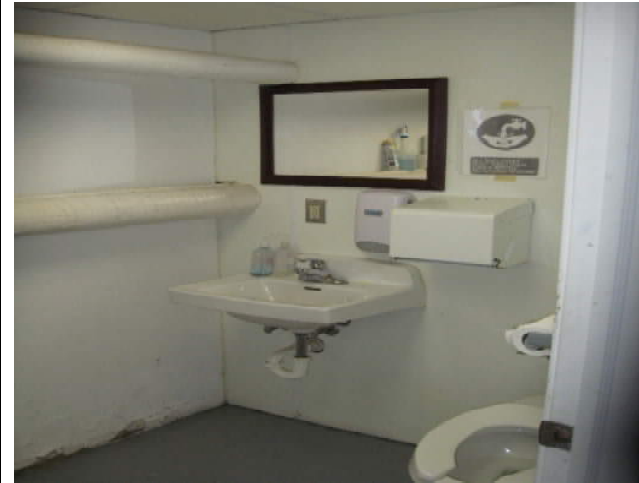
Sink Without Lavatory Guard

Restroom does not meet ADA standards; there are no lavatory guards on the pipes under the sink.

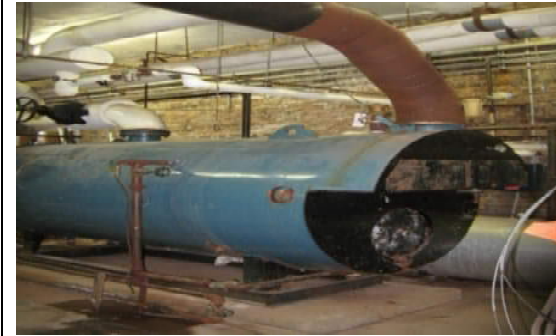
Boiler

The boiler has outlived its life cycle and should be replaced.

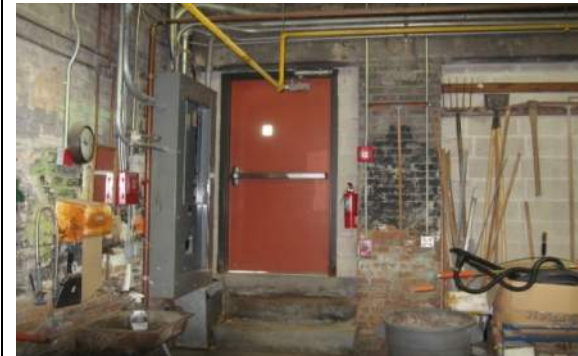
There is no emergency stop button at the boiler room outside the entry/exit. This is a code violation at two doors.

No E-stop Button at Door Entry/Exit

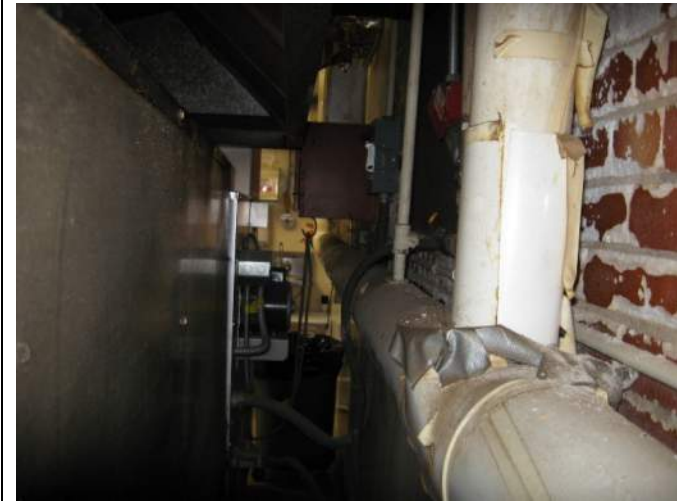
The kitchen exhaust hood has electrical equipment under the hood. Current code calls for the electrical appliances under the hood to be shunt tripped off on Ansul system activation.

Electrical Appliances Under Hood

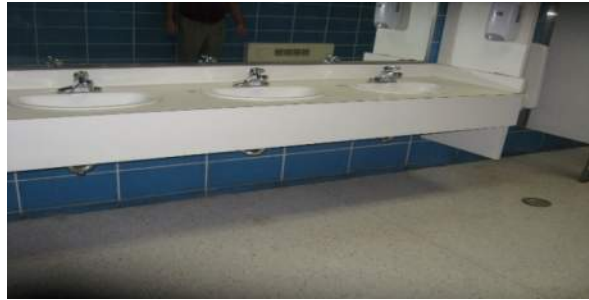
Restrooms are not ADA compliant.

Restroom Sinks

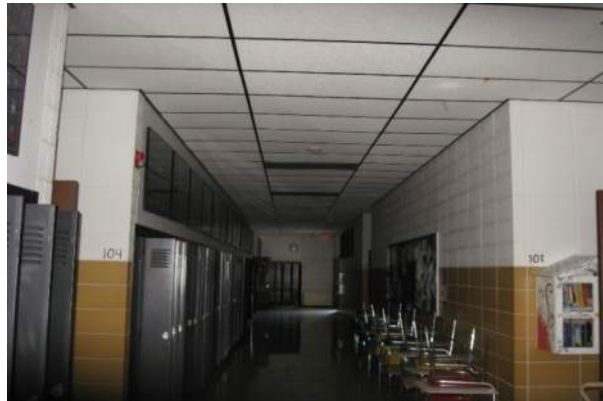
Emergency lighting is not up to code. There are some wall packs but not as many as there should be.

Corridor with no Emergency Lighting

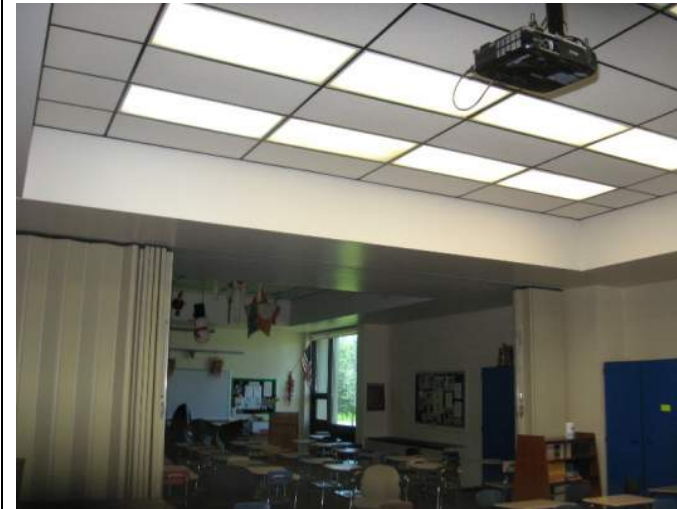
There is no smoke detection in many of the rooms. Code requires either a sprinkled or fully smoke detected building. Many of these classrooms do not have smoke detection.

Classroom Without Smoke Detection

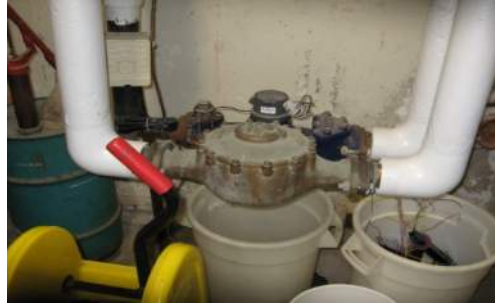
Water Meter

There is no backflow preventer on the water entrance for domestic water and there is no ground jumper wire around the water meter.

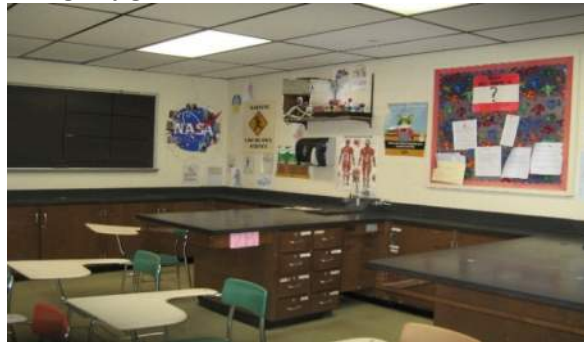
There are two science classrooms and one emergency gas shutoff that feeds both rooms. Each room should have its own emergency gas shut off.

Science Room Without Emergency Gas Shut Off

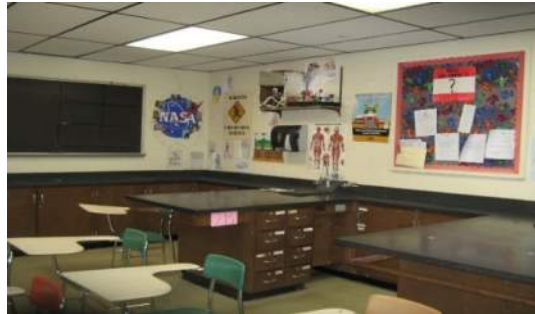
There is no emergency shower in the science classrooms and the eyewash station that is there does not have tempered water. This does not meet the current code. It should have an emergency eyewash/shower in each room, with tempered water.

Science Room Without a Combination Eyewash/Shower

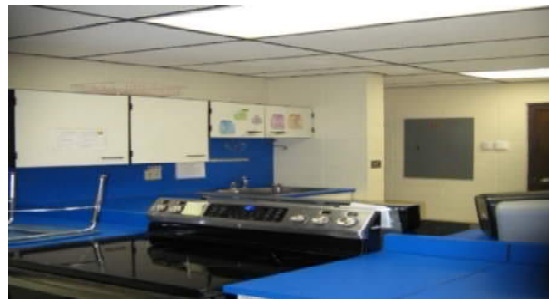
There are no exhaust hoods over the range.

No range Exhaust Hood

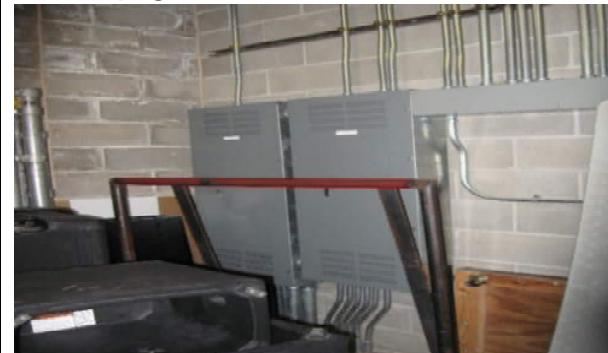
Access to the panels is blocked which is a code issue. No cost housekeeping issue.

Table Blocking Access to Panels

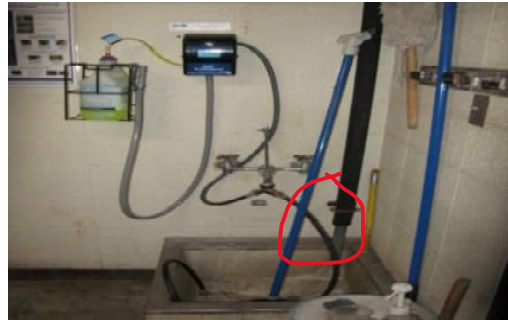
The automatic soap/chemical cleaning dispenser is connected to a faucet that does not have a vacuum breaker on it. If the water were left in the on position, the soap/chemical could contaminate the domestic water supply.

Faucet without a vacuum breaker

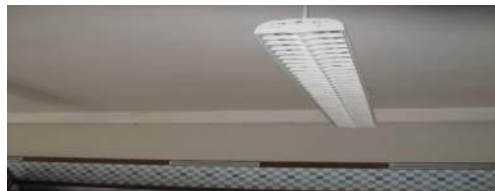
The light fixtures have older fluorescent lamps. Energy could be saved with using LED lamps or LED fixture, occupancy sensor should also be added.

Old Fluorescent Light Fixture

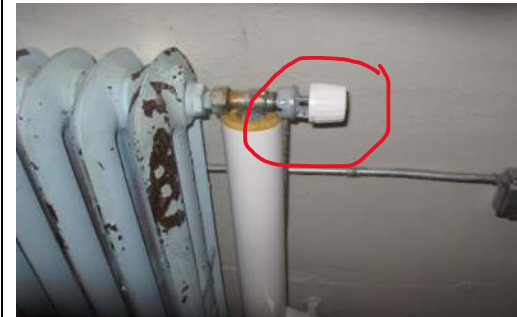
The facility has steam heat with manual control. Electronic control would allow facility maintenance to change the temperature without going into the classrooms.

Radiator with Manual Control

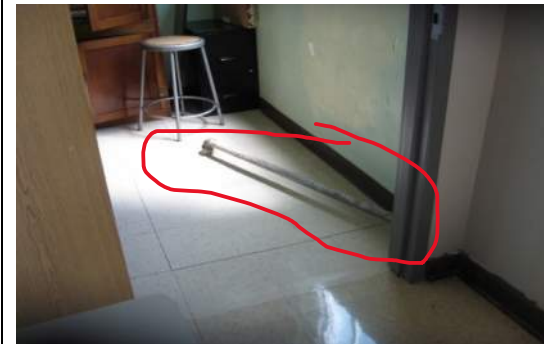
There is a pipe in the middle of the floor that creates a trip hazard.

Pipe in Middle of Floor

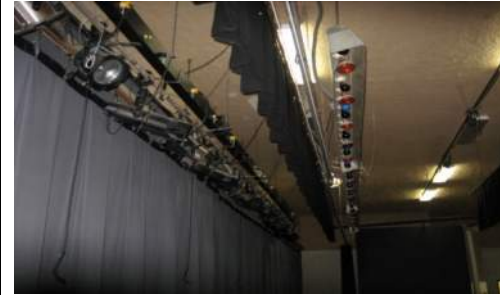
Stage lighting has outlived its life cycle and should be scheduled to be replaced.

Stage Lights

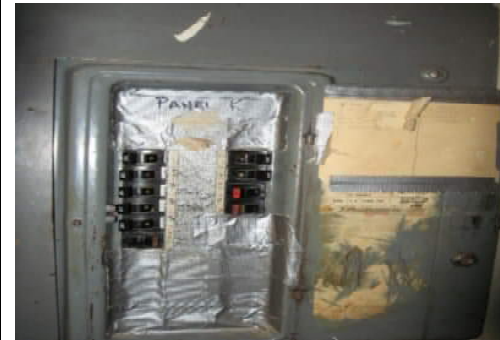
This is another old Federal Pacific electrical panel that needs to be replaced. We assume that duct tape was used because a blank filler plate is no longer available. This is a code issue. This panel should be scheduled for replacement.

FPE Electrical Panel
